STUDIES ON THE DETERIORATION, CONSERVATION AND PIGMENT
COMPOSITION OF MURAL PAINTINGS IN VIHEAR KOMPONG TRALACH
LEU, KOMPONG CHHNANG PROVINCE, CAMBODIA

A Thesis Submitted in Partial Fulfillment of the Requirements
for Master of Arts (CONSERVATION OF FINE ART)
Graduate School, Silpakorn University
Academic Year 2019
Copyright of Graduate School, Silpakorn University

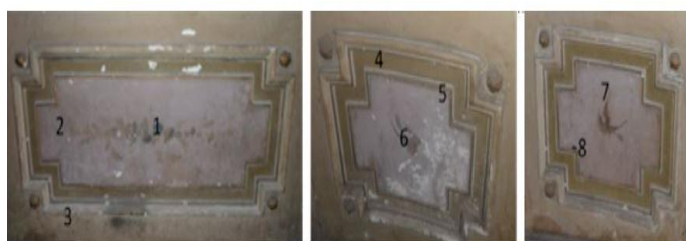
Figure 22 The three mural paintings in El Sakakeny Palace showing sampling points on the damage on the ceiling

In this study, three mural paintings were fully investigated (Figure 22). Besides gaining technical information about this type of painting, the purpose of this research was to acquire knowledge about both the organic and inorganic materials used. The

study comprised the examination of the pigments, media and ground layer [20]. In the conservation state of the paintings to analyses of these paintings were carried out during restoration treatment. From the visual inspection and cross section images, the condition of the paintings is poor, with weakness in the paint layers, which is the most apparent deterioration phenomenon (Figure 23 A-F). There are several areas of the pictorial layer that have become detached, with chromatic alterations around the missing parts, grease and soot spots, and detachment of decorative elements.

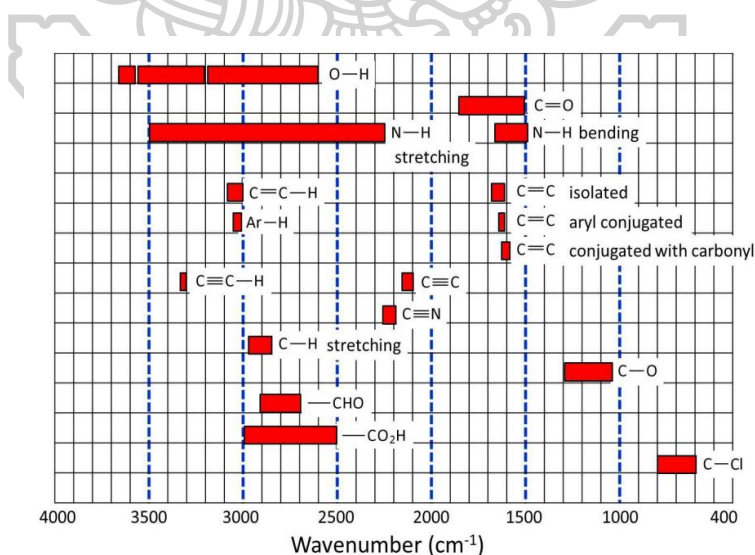
Figure 27 The IR vibrational frequencies for certain functional groups [34]

Each sample can differently absorb IR light at certain wavelengths depending on the functional group existing in the molecule. The IR vibrational frequencies or wave number absorbed by certain functional groups are shown in Figure 27.

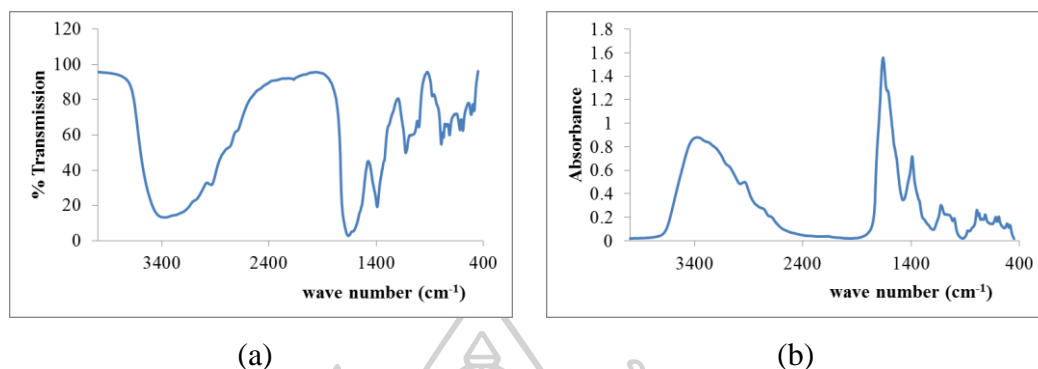
Figure 28 The IR spectrum of silicon protein in (a) transmittance (percentage) and (b) absorbance modes

The IR spectrum is the plot of the transmission percentage (%T) or absorbance against wave number (cm^{-1}) as in Figure 28 (a) and (b).

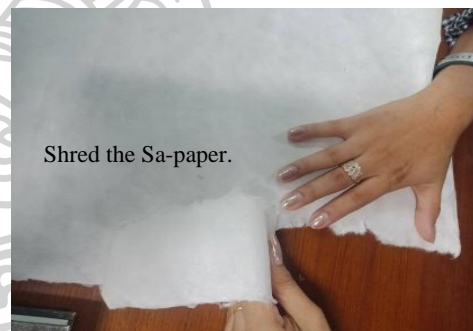
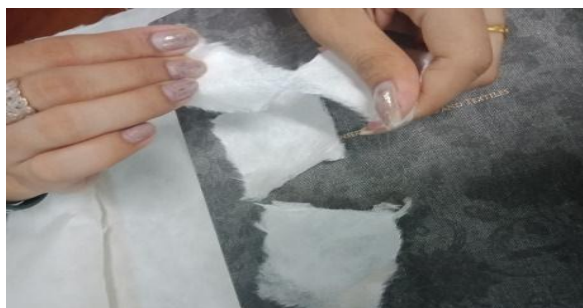
Small pieces of shredded Sa-paper

1. The 54 cm x 80 cm Sa-paper, made in Thailand, was shredded into small pieces as in the following figure:

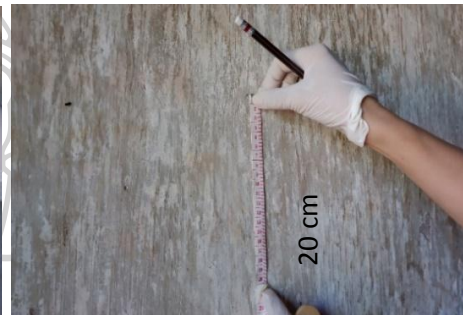
- Mark the area of 20 cm x 20 cm on the wall as in the following figure:

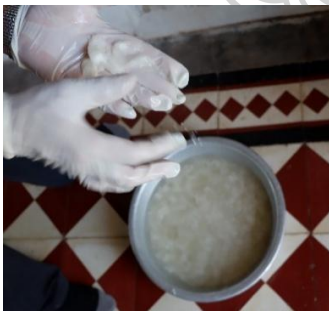
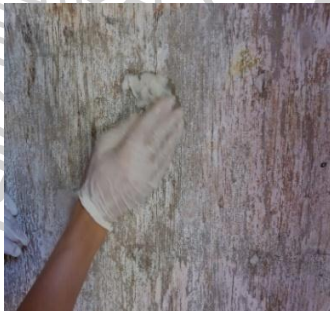
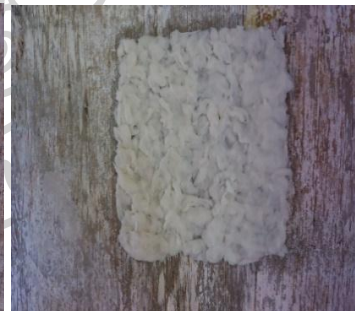
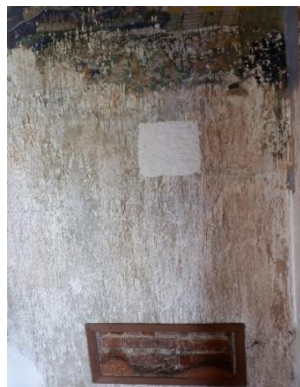
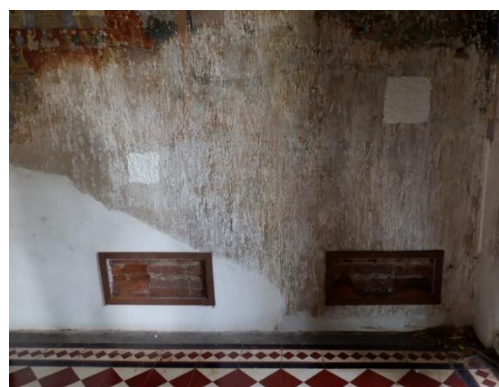
- The soaked Sa-paper was attached on to the three marked areas as the detail below:

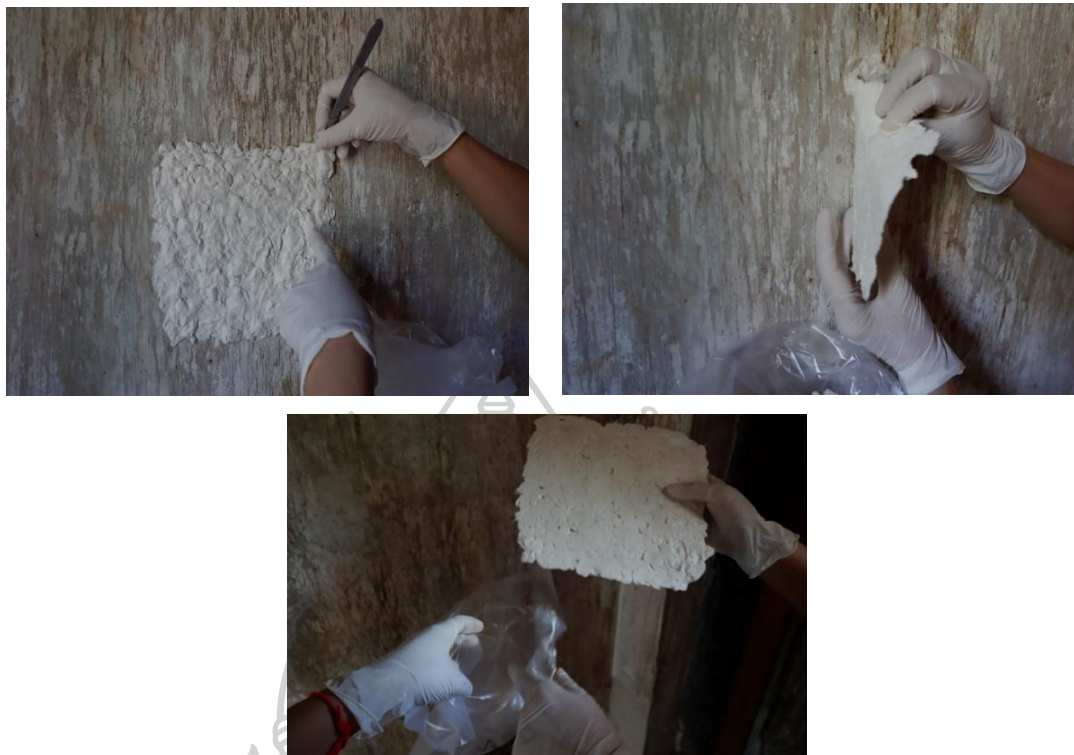
5. After 3 days, the dry Sa-paper was detached softly using scalpel. Keep the Sa-paper in Zip-locked plastic back for the scientific analyses.

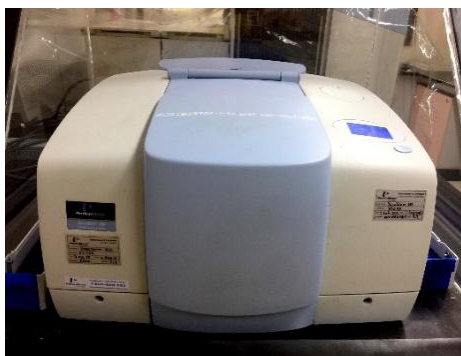
Figure 40 The Fourier Transform Infrared Spectroscopy (FTIR) spectrometer

The old and new plasters were analyzed by Spectrum 100 FT-IR spectrophotometer (Perkin Elmer) in both transmittance and reflectance modes. The functional group analyses on each sample are recorded.

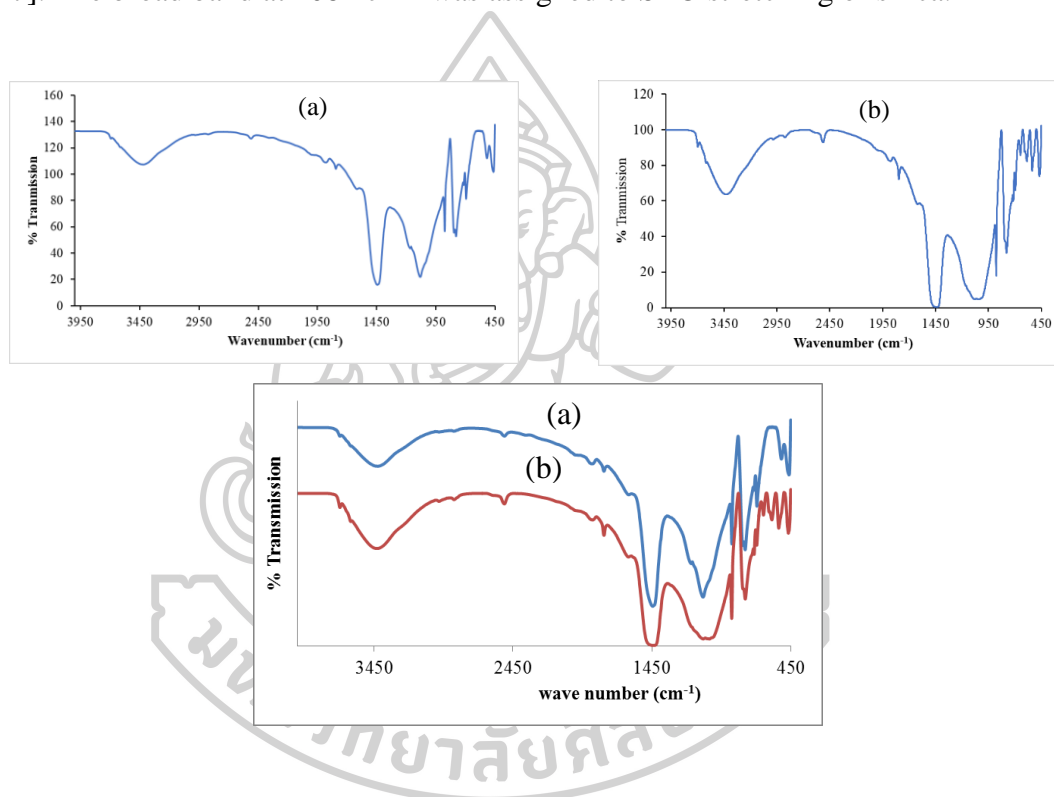
Figure 41 FT-IR spectrum of the sampling (a) old plaster and (b) new plaster
