OBSERVATION AND CONSERVATION REPORT ON KANCHANABURI PAPER
MILL; INDUSTRIAL HERITAGE OF THAILAND

Title Observation and Conservation Report on Kanchanaburi Paper Mill;
Industrial Heritage of Thailand
By Mr. Zay Myo LIN
Field of Study Architectural Heritage, Creative Industries and Tourism
Management (International Program) Plan B
Advisor Associate Professor Kreangkrai Kirdsiri, Ph.D.

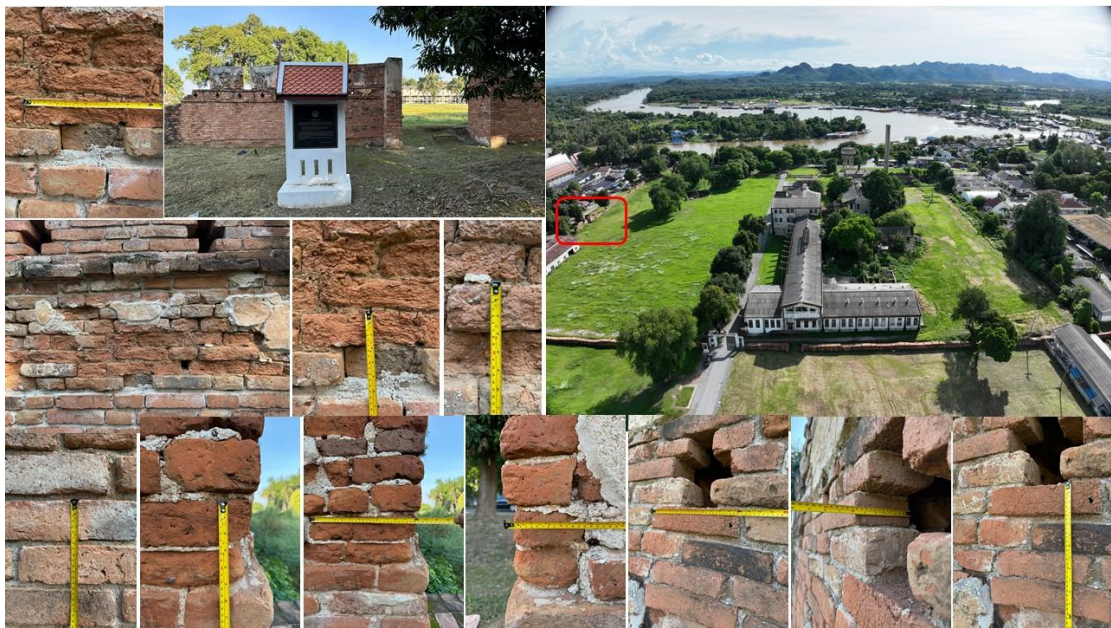
Restoration, reconstruction and re-pointing efforts have been undertaken on certain sections of the brick wall, utilizing bricks of the same dimensions and lime-based mortar. The thickness of the mud mortar between the bricks typically measures 3.5 to 4.5mm in horizontal layers and 2.5 to 3 mm in the vertical gaps. This works has been carried out by the Ministry of Fine Arts, as indicated on the information board. **(Figure 1)**

Figure 1: Remnant of ancient brick wall at Kanchanaburi paper mill by 01/12/2024

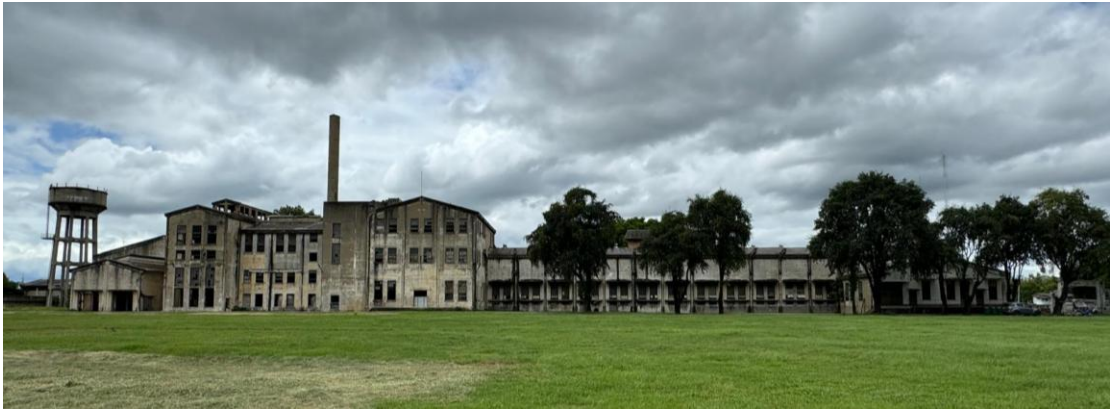
The identity of the architect and builder engineer remains unknown that required to do further research; however, the essence of modern architecture, which prevailed in the Western world from the 1930s to the 1960s, is evident in this structure. This architectural style is marked by a pragmatic and analytical approach to design, this paper mill exemplifies a design philosophy that emphasizes analytical and functional principles, featuring elements such as mansard roofs, open floor plans, curtain walls, and expansive volume that enhance natural lighting and cross ventilation, all while adhering to a minimalist aesthetic. The visual appeal of this modern industrial edifice, marked by its adorned columns, is closely linked to the early developments of Brutalist architecture that gained prominence in the 1950s. The architect's intention was to maximize natural light and open spaces, thereby fostering a work environment that promotes well-being and reduces stress for its occupants. The Introduction of modern architecture, often referred to as international modernism, reached Thailand in the context of industrial development in 1937, at Kanchanaburi. This architecture style was particularly suited for building designed to accommodate heavy industrial machinery imported from Germany, necessitating specific requirements regarding land area, spatial configuration, and essential infrastructure **(Figure 3)**.

Figure 3: South side of Kanchanaburi paper mill

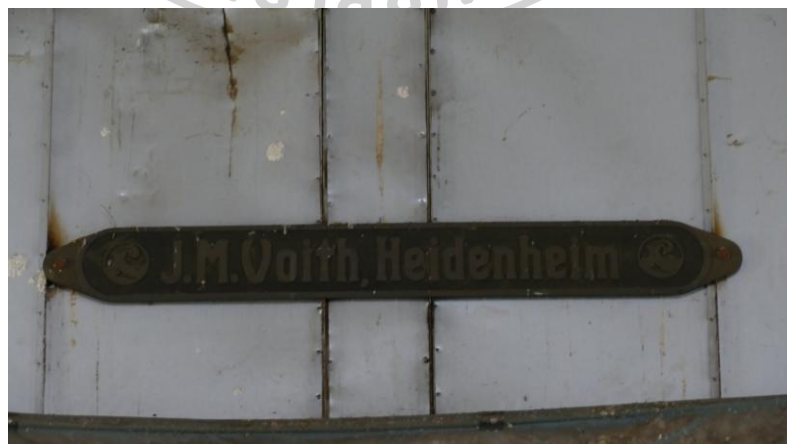
Figure 4: Company logo founded at the heavy machinery at Building A, production hall

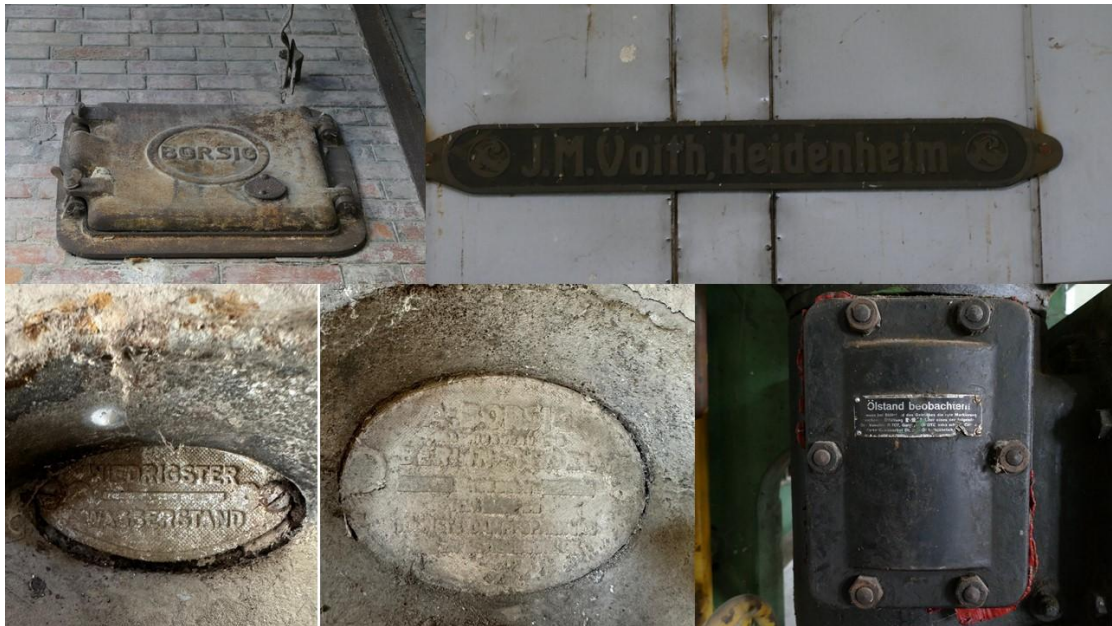
Based on a site survey carried out in 2024 indicates that a significant portion of the remaining heavy-duty machinery is sourced from the German company *J.M. Voith Heidenheim*, located in Berlin (**Figure 4, 5**). The supplier of machinery for Kanchanaburi paper mill, *J.M. Voith Heidenheim*, is likely to possess valuable insights regarding architectural, civil, and structural designs that have been implemented in similar projects across Europe. These insights are essential for meeting the stringent structural requirements, layout specifications, and mechanical and electrical needs of paper mills, where precision is paramount. It is plausible that *J.M. Voith Heidenheim* collaborates with architects and engineers to develop a comprehensive master plan (**Figure 6**).

Figure 5: German company logos and signs founded at the heavy machinery at paper mill
 Photo by Zay Myo Lin, (2024)

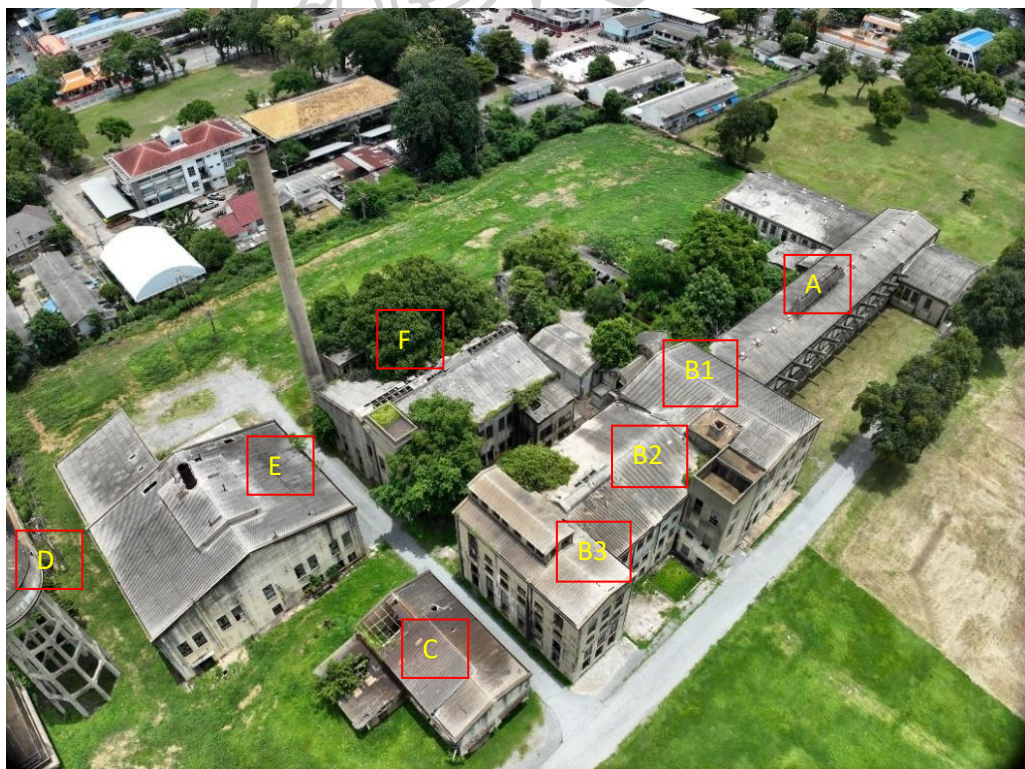
Figure 6: Existing Master Plan of Kanchanaburi Paper Mill complex.
 Aerial photo by Professor Isarachai Buranaut, 2024.

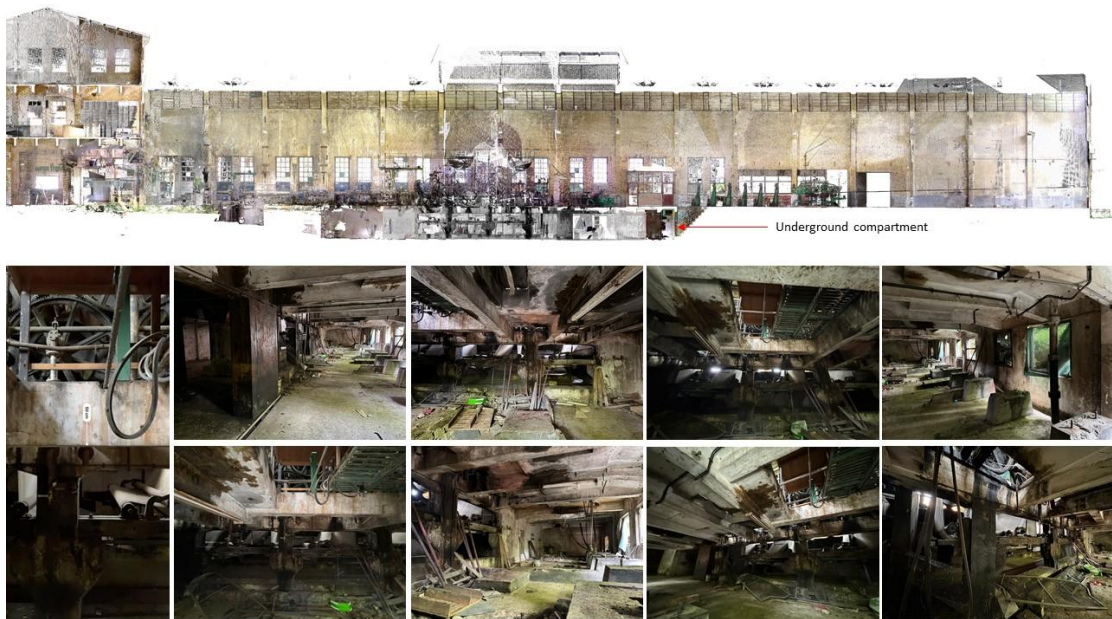
The design of Building A features a T-shaped layout that incorporates an underground compartment situated beneath the area designated for heavy-duty machinery. This underground space is intended to facilitate convenient access during the installation of heavy machinery, while also serving as a crucial component for routine maintenance activities (**Figure 9**).

Figure 9: 3D section of underground compartment and photos at Building A
3D scanning by professor Isarachai Buranaut and photos by Zay Myo Lin (2024).

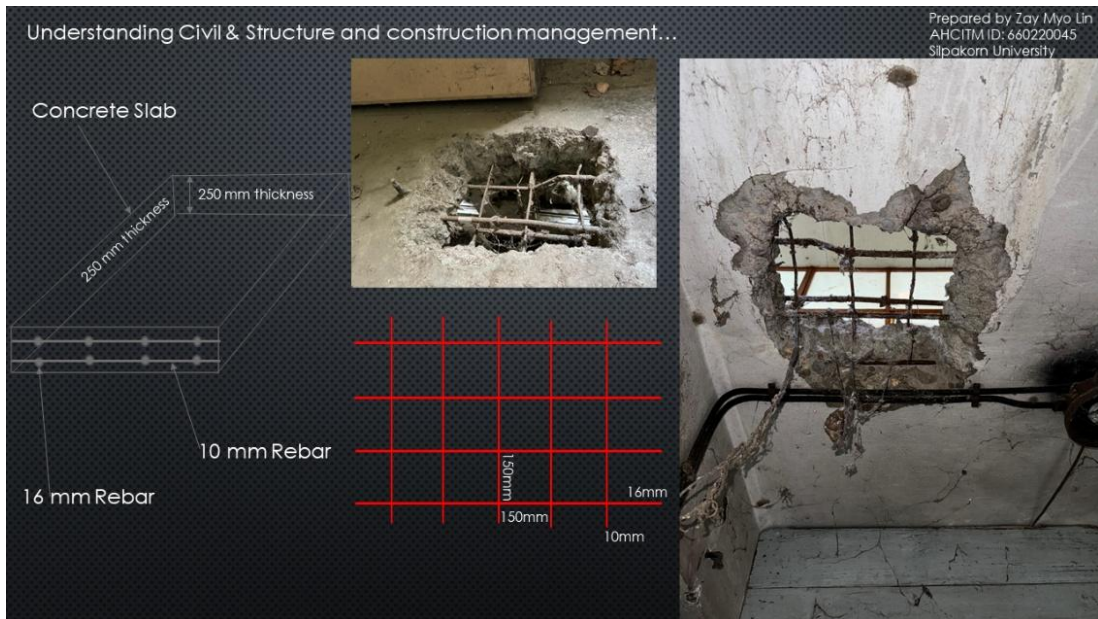
The first floor is the only one level at Building A, the floor, wall, column, beam and joists at roof are all made of concrete. The thickness of the reinforced concrete slab is specified to be 200 millimeters, utilizing reinforcement bars of sizes 16 millimeters and 10 millimeters (**Figure 10**). The composition of the concrete mix consists of cement, sand, and 4-20 mm sub base aggregate river gravel. The total estimated tonnage of aggregate, cement, and sand required for construction of 1 floor slab is 735.52 tons. The delivery capacity is facilitated by standard tipper trucks, which can carry loads ranging from 15 to 20 tons. Reinforce concrete slabs are structural elements that incorporated steel reinforcement to enhance the load-bearing capacity and durability. This combination of concrete and steel allows the slab to withstand tensile forces, with concrete alone cannot effectively manage. The design and implementation of reinforcement of reinforced concrete slabs are critical in paper mill construction application, providing a robust foundation for building and other structures. By integrating reinforcement within the concrete matrix, the engineer who designed has optimize the performance of the slab, ensuring it meets the necessary safety and performance standards specially to host heavy machinery imported from *J.M. Voith Heidenheim*, Germany.

Figure 10: Building A, floor slab of level 1, ceiling of basement compartment
 Photo by Zay Myo Lin, (2024)

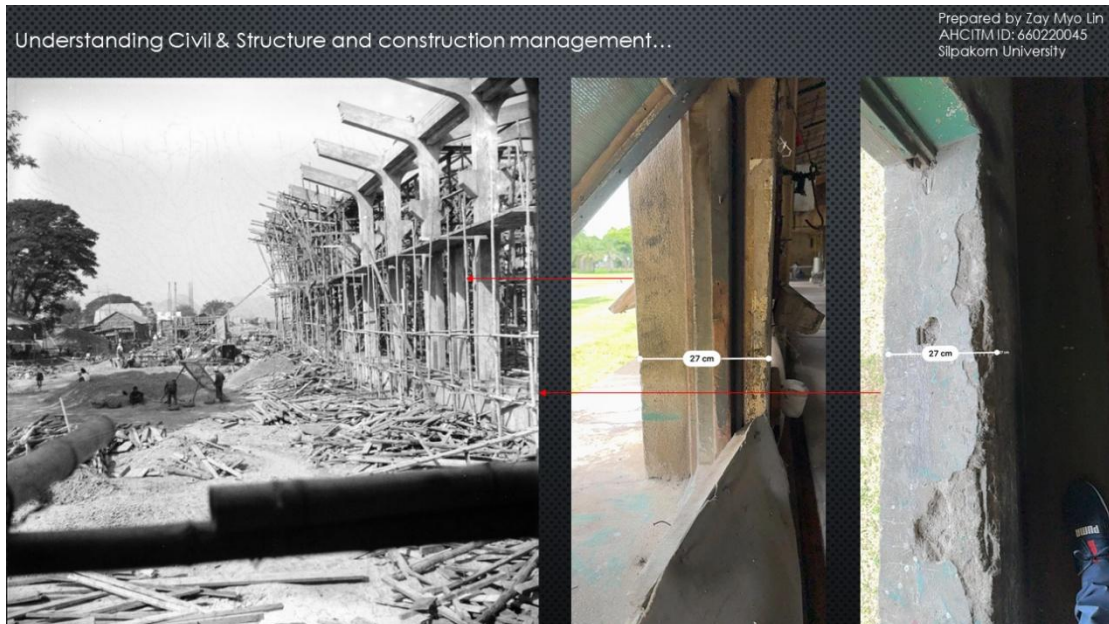
Figure 11: Walling work in progress in 1937 and onsite measurement conduct in 2024

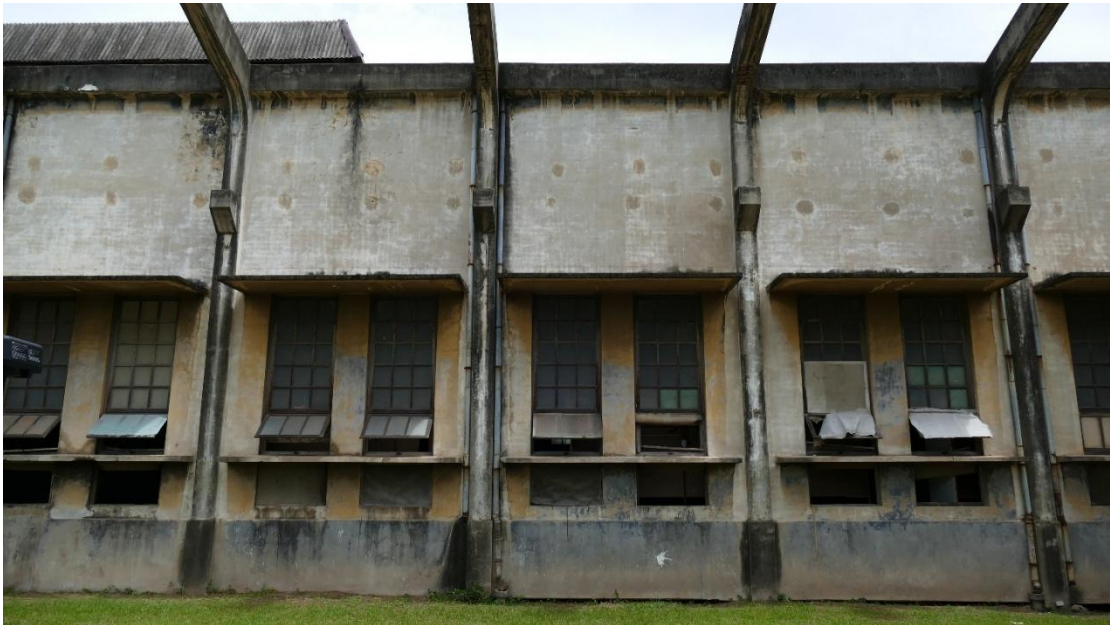
transition between different environments, while walls act as both physical barriers and aesthetic components that shape the overall design. Together, they reflect the principles of modernism, emphasizing simplicity, utility, and the integration of form and function in architectural practice (**Figure 12**).

Figure 12: Façade and Window of Building A, Production Hall

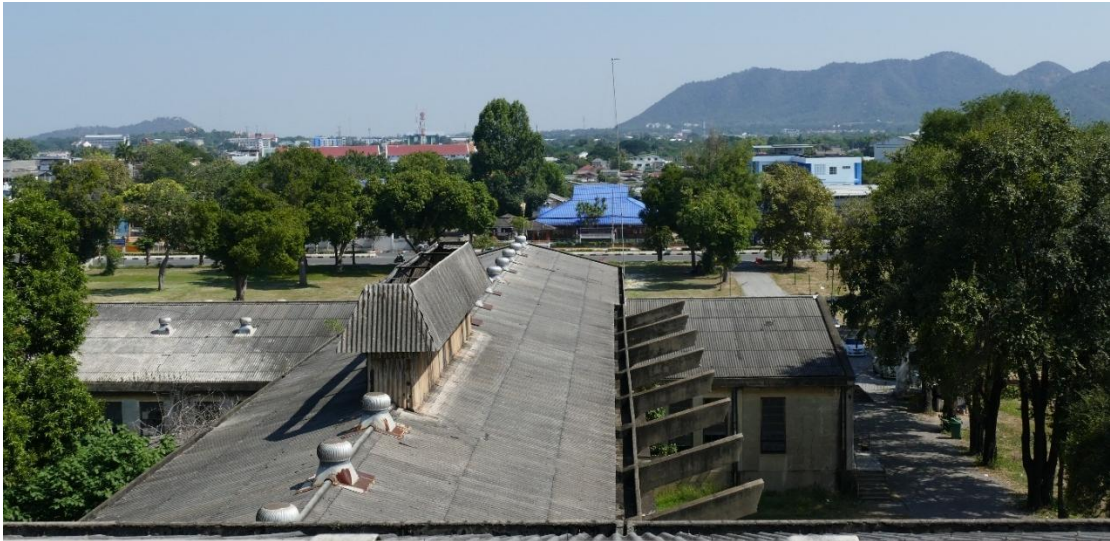
The primary frameworks for the roofing system consist of inclined rafters, which are derived from the main columns and interconnected by noggins arranged in linear formations, constructed from reinforced concrete. The purlins that support the roofing, along with the ceiling joists, are established using **steel C channels**. The roofing is composed of **fiber cement sheets**, providing durability and structural integrity (**Figure 13**).

Figure 13: Roofing of Building A, Production Hall

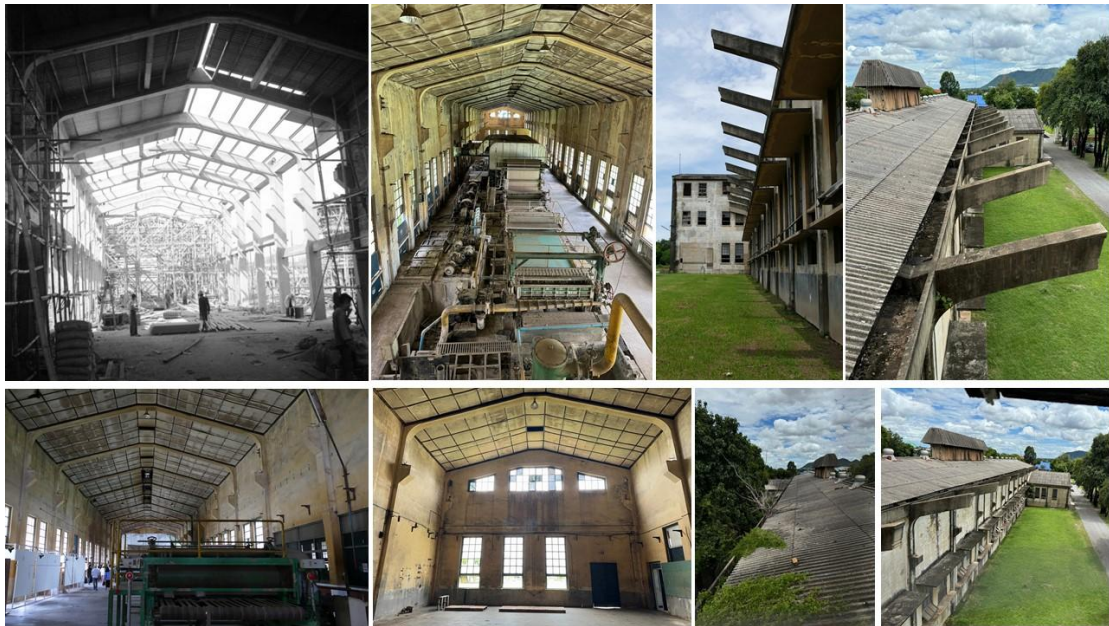
The current state of Building A is characterized by a T-shaped layout of the production hall, which stands out as the most favorable condition among the various structures within the complex. All structural components are intact and exhibit no defects, including the shear walls, which are constructed from reinforced concrete and show no signs of cracking. In contrast, if the walls had been made of brick, one could expect numerous creaks and defects both externally and internally. The existing concrete flooring has largely retained its original form; however, certain metal sheets and wooden flooring over access points and underground channels are in poor and unsafe condition. Additionally, the doors and windows are not functioning optimally, primarily due to a lack of regular maintenance over the past several decades. While the main entrance door remains in satisfactory condition, it still required repair and restoration efforts to ensure proper functionality. The roofing of the building is generally in good shape, although there are noticeable signs of water leakage, evidenced by water stains on the ceiling panels. Furthermore, the built-in gutters, rainwater downpipes, and the drainage system at ground level are not operating effectively, which may exacerbate the issues related to water management within the facility (**Figure 14**).

Figure 14: Interior and exterior of Building A, production hall

Recommendation for emergency response involves the restoration of the roofing, doors, windows, and the inserted floor on level one. The roofing is crucial for the preservation of heritage buildings, as it prevents water leakage and rainwater intrusion, which can cause significant damage throughout the structure. In this case, all machinery and equipment remain intact on-site, making the maintenance of the roof directly linked to the protection of these assets. The integrity of the building is compromised if the roof fails. It is essential to clean all gutters, downspouts, and drainage systems to eliminate any debris that could obstruct proper water flow. Additionally, restoring the functionality of doors and windows is necessary to re-establish security, pest control, lighting, and ventilation. The inserted floor within the interior also requires repair and proper fitting, as the building accommodates over 700 visitors on weekends, some of whom attempt to access the interior by opening unsecured windows and doors. Furthermore, the installation of a fire-fighting system is being considered, with mobile fire extinguishers recommended as emergency fire protection equipment.

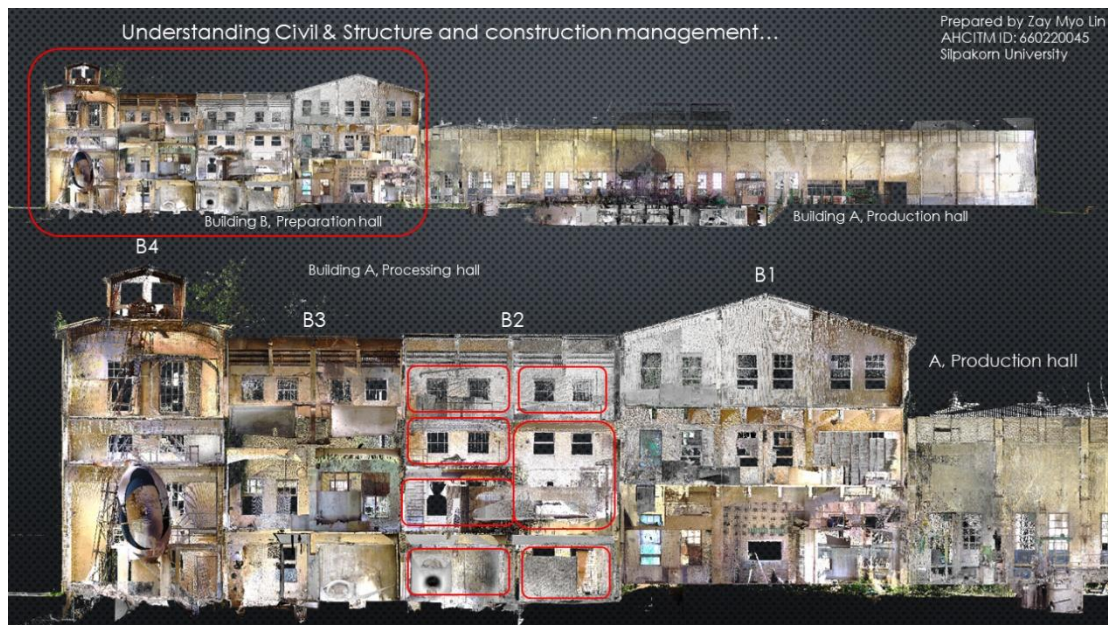
The **B4** building features a double-height volume on the first level, which is necessary for operational purposes due to the presence of a large steel container cylinder that extends through a hole in the second-level slab. The second level has a lower ceiling and is linked to building B3 through an access door. In contrast, the third level boasts a high ceiling that connects directly to building B1 via an access pathway. Additionally, there is a small structure situated atop the third floor served as observation room, providing a panoramic view of the entire paper mill complex, the surrounding landscape, and the river.

Figure 15: Section of Building B consist of 4 building 3D scanning by professor Isarachai Buranaut.

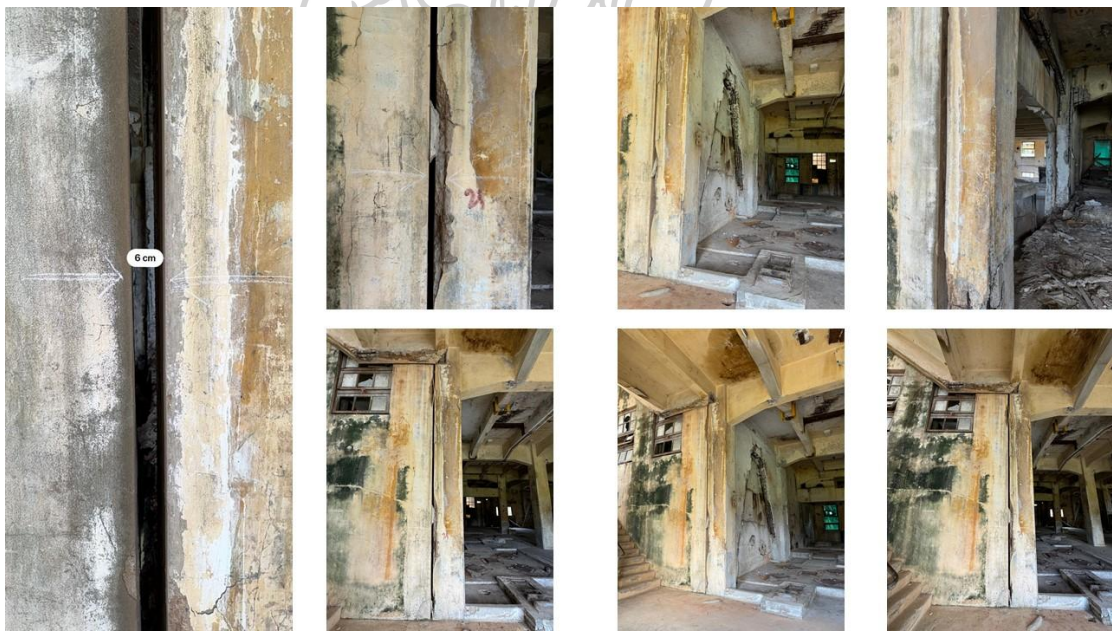
The wall adjacent to B1 and Building A may have been built in a subsequent phase, occurring only after the installation of equipment on the first floor. It is likely that the construction of **B1** began with the establishment of both superstructure and substructure, followed by the construction of the floors slab and roof. Furthermore, certain sections of the floor and wall were intentionally left without slab and walling to facilitate vertical access during the installation of machinery, as evidenced by the presence of a wooden plank floor at the fourth level. The final stage of B1's construction involved the erection of walls through bricklaying, which accounts for the existence of two separate walls through bricklaying, which accounts for **the existence of two separate walls** positioned closely together between B1 and Building A (**Figure 16**).

Figure 16: The two separate walls through bricklaying, which accounts for the existence of two separate walls

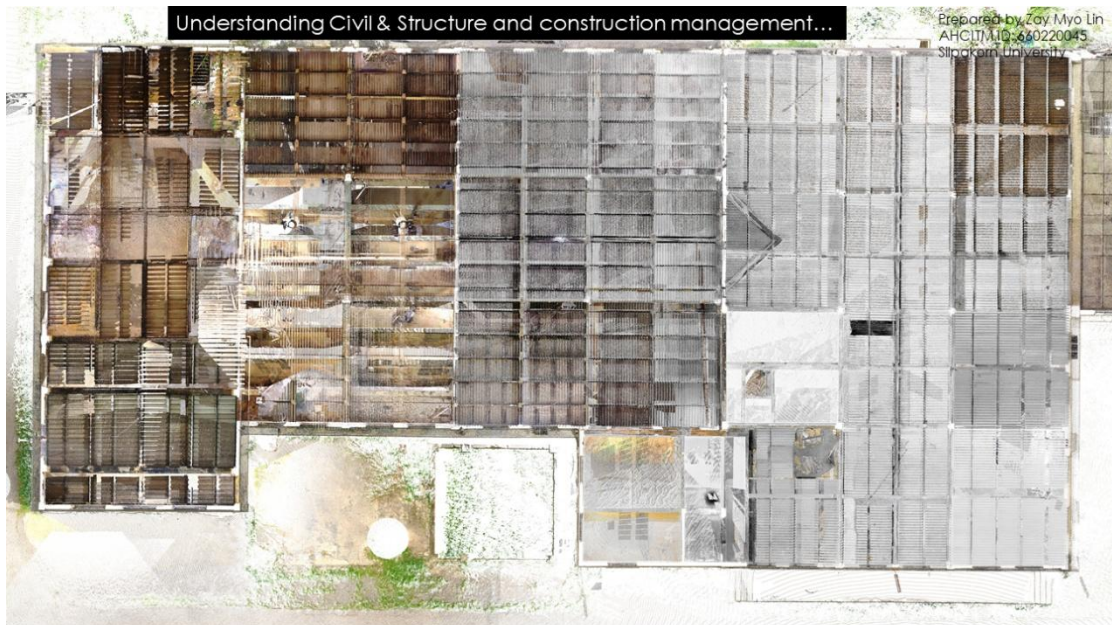
The integration of beams in reinforced concrete structures is essential due to their fundamental function in ensuring the support and stability of the entire building framework. Within a span of three meters, three concrete beams have been constructed, each featuring various rebar designs and sizes tailored to meet the specific operational requirements dictated by the nature of the building. Notably, Building B is recognized as the most extensively constructed beam structure, not only within the Paper Mill complex but potentially throughout Thailand's construction industry during the 1930s (**Figure 20**).

Figure 20: Building reinforced beam overall plan
3D scanning by professor Isarachai Buranaut

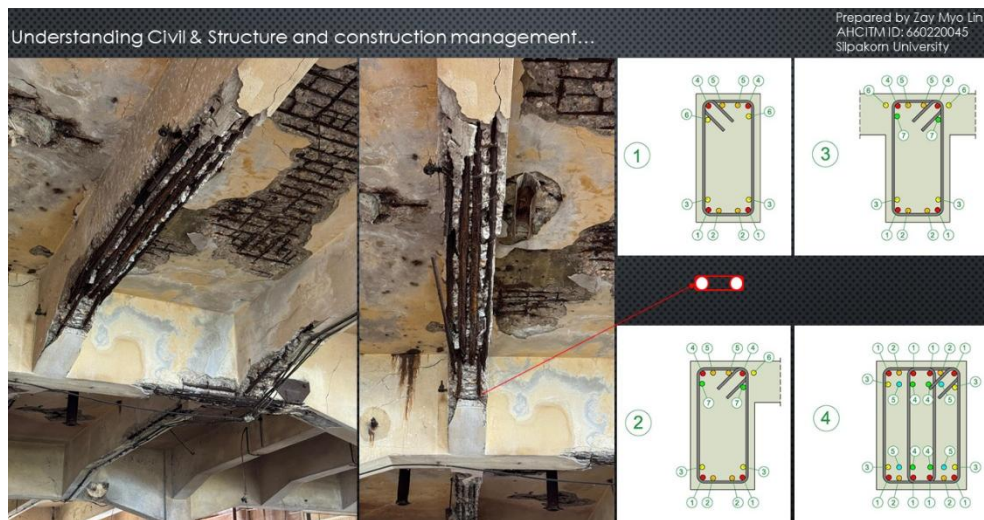
Figure 21: 4 type of beam founded as major group in Building B
Photo and drawing by Zay Myo Lin, (2024)

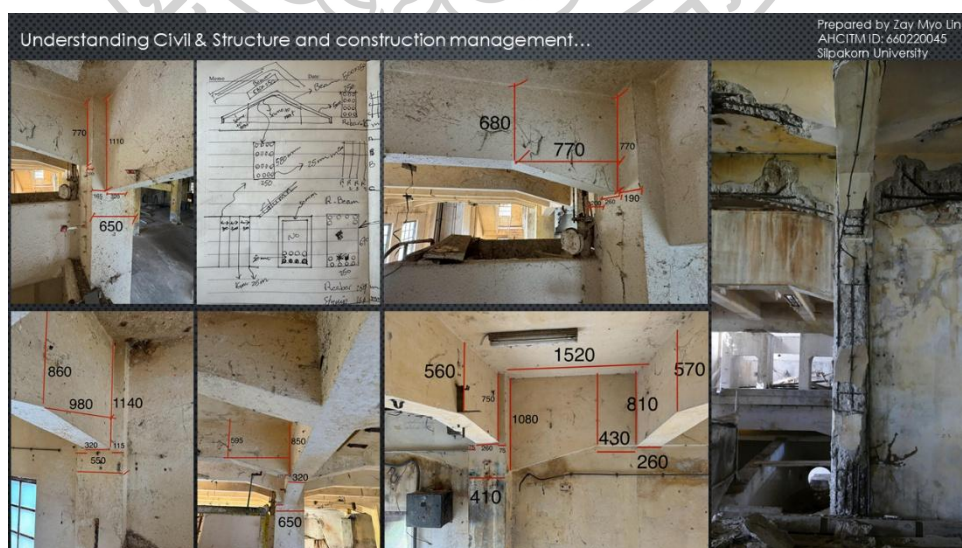
a slab or structure to offer additional support and rigidity, and internal beams, which are situated within the slab to further reinforce the structure and facilitate load distribution. Additionally, the concept of tension stiffening is relevant in reinforced concrete, where the concrete between cracks can still sustain some tensile stress due to its bond with the reinforcement, thereby contributing to the overall stiffness of the structure (**Figure 22**).

Figure 22: Stiffened concrete beam founded in Building B
Photo and drawing by Zay Myo Lin, (2024)

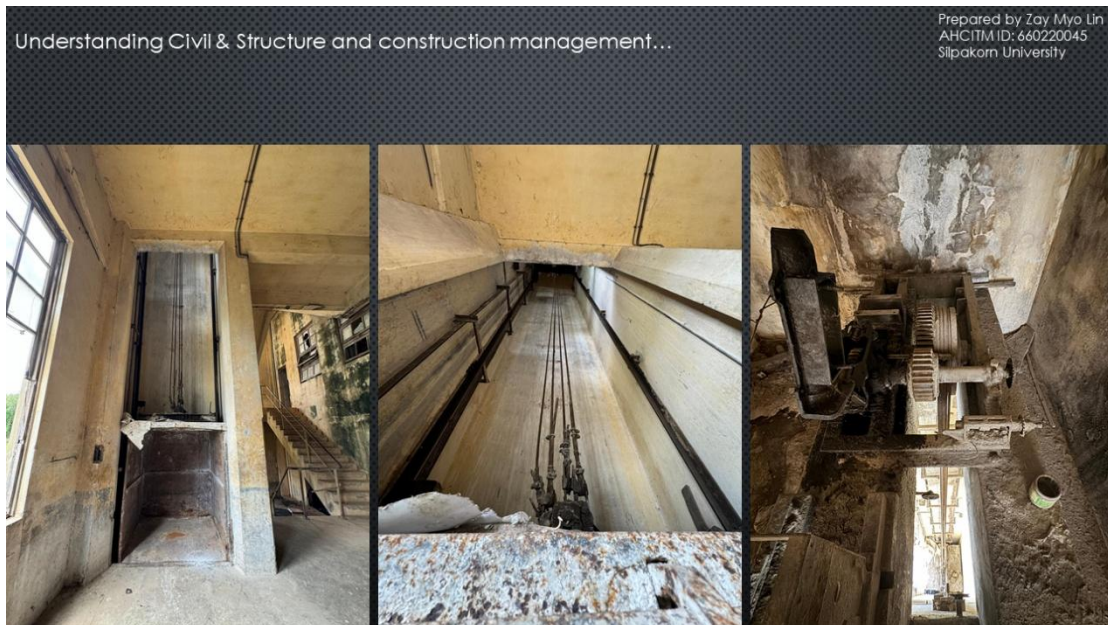
Building B1 and B2 was connected by adjacent building built for elevator and staircase, a reinforce concrete staircase could access to both building and an elevator shaft have been integrated; however, the elevator access door face B1. Notably, this elevator represents **the inaugural elevator in Thailand** marked a significant advancement in the country's architectural and engineering landscape. This innovation not only facilitated vertical transformation within buildings but also symbolized the modernization of urban infrastructure. The introduction of the elevator played a crucial role in shaping the design and functionality of high-rise structures, ultimately contributing to the evolution of Thailand's urban environment, especially at the Kanchanaburi paper mill, where it was installed concurrently with the completion of the preparation process building **since 1937**. A significant investment of 12.9 million bath was made in this Paper Mill to acquire a comprehensive set of machinery from Germany, which notably included an electric motorized elevator designed to facilitate transportation within a prospective four-story building (**Figure 23**). This acquisition marked a pivotal moment in the industrial history of Thailand, reflecting the country's evolving capabilities in manufacturing and infrastructure development. It is widely recognized that the inaugural elevator for human transportation in Thailand was introduced in 1958 within the Garden Wing of the Mandarin Oriental, Bangkok, but in fact, it was the second. The presence of an elevator in the pulp paper mill situated in Kanchanaburi may be perceived by many as a standard feature of a building. However, it holds considerable significance that distinguishes it from other industrial structures in Thailand. This elevator represents a unique value and marks an important development in Thailand's industrial landscape during the 1930s.

Figure 23: Elevated lift car, lift shelf and mortar room located above 4 story building
 Photo by Zay Myo Lin (2024).

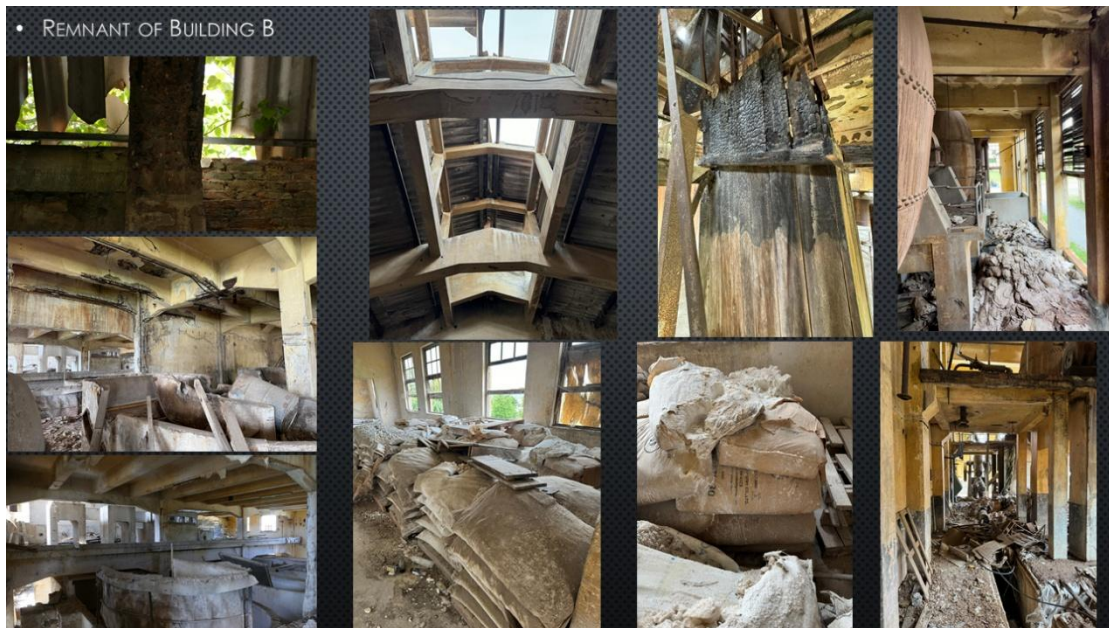
The roofing structure has suffered significant damage, with roofing sheets exhibiting breakage attributed to insufficient maintenance. Additionally, numerous windows, doors, panels, and louvers are non-functional, also due to a lack of proper upkeep. Many glass panels are either broken, missing, or malfunctioning, which poses a risk of water leakage and subsequent corrosion. Evidence of monitor lizards has been observed on the ground floor, while traces of pigeons are present on every level. The presence of non-organic bird waste further exacerbates the potential for corrosion. There are remnants of lime, limestone, and unidentified chemical substances found within open tanks and on the flooring. The B3 area is heavily cluttered with debris, resulting in a complete coverage of the floor. Furthermore, there are significant vegetation issues affecting the roofing, walls, and extending down to the base of the building's exterior (**Figure 24**).

The structural components of the building, including the floor slab, walls, columns, beams, joists, and roofing elements, have remained intact since their construction in 1937. There are no significant damages or functional failures attributable to earthquakes or other natural disasters. Overall, Building B is in satisfactory condition; however, some walls, columns, and beams exhibit exposed rebar, likely resulting from a destructive testing process that involved the hacking away of concrete. The exposed rebar has suffered considerable corrosion due to prolonged exposure to the elements and moisture, exacerbated by inadequate ventilation within the building's interior. This deterioration poses a risk of structural failure if immediate protective measures are not implemented. It is crucial to address these issues promptly to ensure the integrity and safety of the structure.

Figure 24: Remnant of Building B

1. The management of housekeeping and debris removal is essential to prevent fire incidents and implement effective pest control measures. Notably, there are signs of burn damage on the upper section of Building B3, where rafters and joists have suffered significant charring due to elevated temperatures, indicating a potential fire outbreak. The restoration of doors and windows is the next priority, as this will aid in pest control and enhance security measures.

2. The immediate replacement of damaged roofing is crucial, followed by the clearing of debris and vegetation from the gutters. It is also necessary to restore the rainwater downspouts to ensure the proper functioning of the drainage system. Additionally, the removal of limestone bags should be considered to prevent any chemical reactions that could affect exposed metal and steel components.

3. Most critically, there is an urgent need to protect exposed steel and rebar elements within the columns, beams, and walls. Applying anti-corrosion paint as an initial protective measure is essential, and it may also be necessary to use epoxy paint for structural reinforcement purposes. This proactive approach will help safeguard the integrity of the building's structural components.

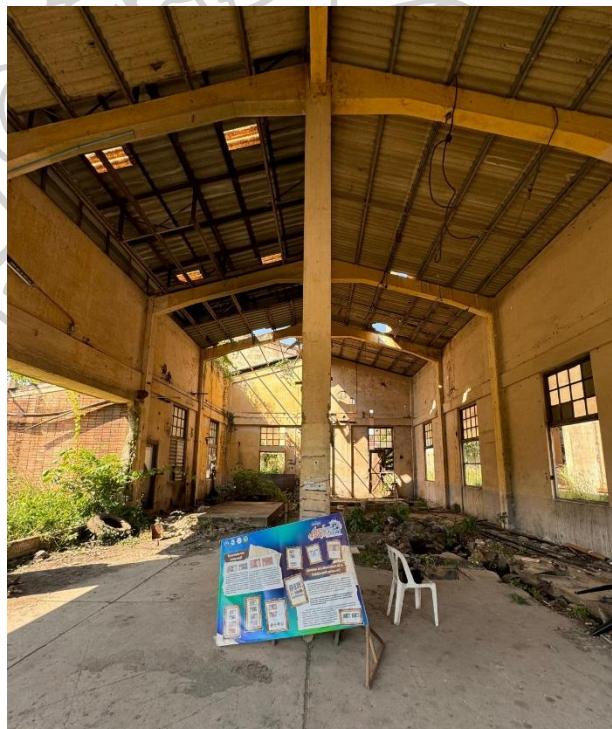
Architecture of this industrial warehouses reflects a significant evolution in design principles and functionality. This architectural style emphasizes efficiency, adaptability, and sustainability, catering to the needs of contemporary industrial operations, allows for expansive open spaces, maximizing utility while minimizing unnecessary structural elements. The design of this warehouses often incorporates windows and open floor plans, promoting natural light and enhancing the working environment. This approach not only improves energy efficiency but also fosters a more pleasant atmosphere for employees. Furthermore, modern industrial warehouse architecture often prioritizes flexibility, allowing spaces to be easily reconfigured to accommodate changing operational requirements. This adaptability is crucial in a rapidly evolving pulp paper manufacturing, where the supply chain must respond swiftly to new challenges and opportunities. Overall, the modern architectural approach to industrial warehouses represents a harmonious blend of functionality, sustainability, and aesthetic appeal (**Figure 26**).

Figure 26: Structural elements and interior of Building C

The foundation and floor slab, along with the pitch and channels, remain intact as originally constructed. The walls, columns, beams, and all structural components are in satisfactory condition, reflecting their initial state. Additionally, roofing elements, including joists, purlins, ventilation panels, and natural light panels, continue to be in good condition. However, the doors and windows have suffered damage and are not functioning properly, primarily due to a lack of maintenance. The roofing sheets have also sustained damage, leading to water leakage from the roof to the ground floor, which has been observed. Furthermore, remnants of electrical wiring and lighting do not adhere to proper cabling standards, and there is some vegetation present around the building.

The primary focus is to resume roofing work to ensure complete protection against rain and adverse weather conditions. Following this, the restoration of doors and windows will be prioritized to address issues related to pests, weather damage, and security concerns. Additionally, it is essential to implement proper cabling for lighting and power sources in accordance with established building codes. Maintaining cleanliness and removing debris from within the building is also crucial to mitigate the risk of fire hazards. In conjunction with these efforts, the removal of vegetation surrounding the building will be addressed as part of the final maintenance activities. This step is important for enhancing the overall safety of the premises. Furthermore, it is advisable to install fire extinguishers and safety signage, particularly since the building remains accessible to visitors. These measures will help prevent accidents such as trips and falls. Overall, a systematic approach to these maintenance tasks will not only improve the building's structural integrity but also enhance safety for all individuals who enter the premises. By prioritizing roofing, restoring entry points, ensuring compliance with electrical standards, and maintaining a clean environment, the building can be made safer and more secure.

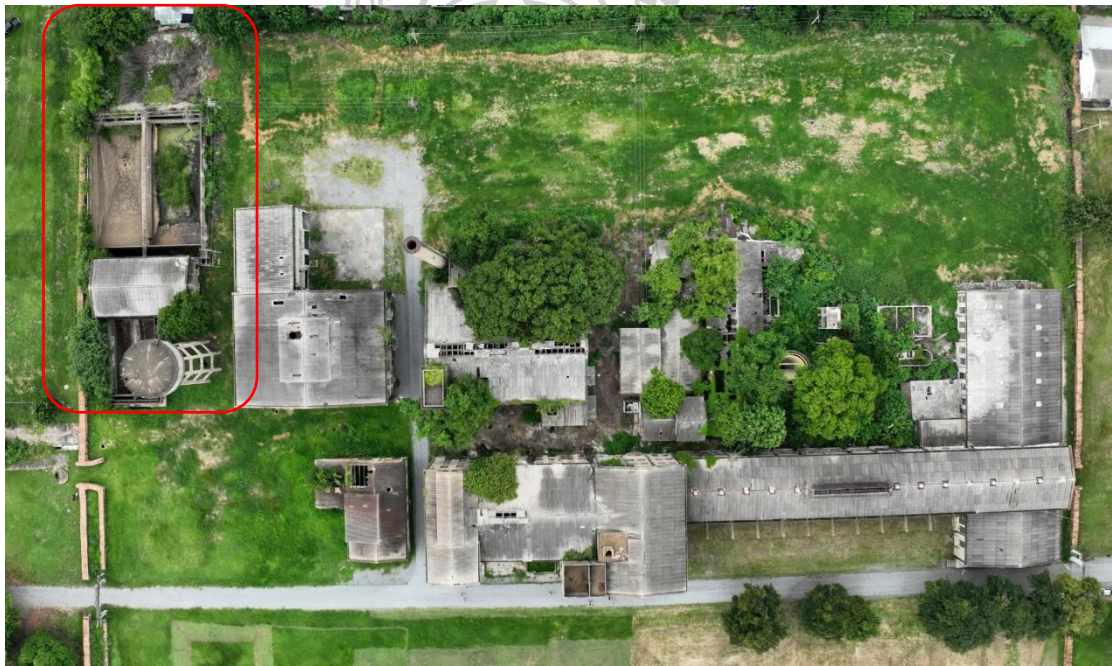
The Building D group comprises an overhead water tank system, a series of water tanks situated above ground, and a facility dedicated to water distribution management. The primary function of the overhead water tanks is to provide domestic water supply, while the additional above-ground tanks may serve purposes such as supplementary storage and potentially wastewater treatment (**Figure 27**).

Figure 27: Building D group

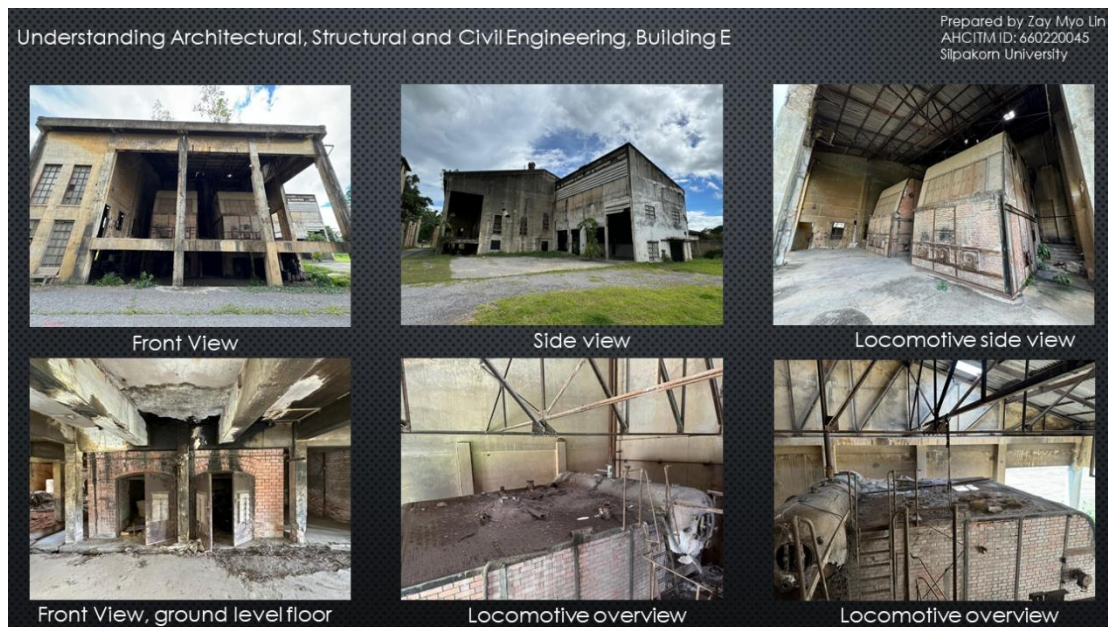
The Architecture of building E is thoughtfully designed to accommodate locomotive engines, emphasizing open floor plans that characterize industrial buildings. These designs typically incorporate expansive, unobstructed areas to enhance production efficiency and streamline workflow. Additionally, the incorporation of high ceilings not only permits the installation of machinery and equipment but also ensures sufficient vertical space for the workforce. The use of robust materials such as concrete, brick, and metal contributes to an impression of strength and resilience, while simultaneously embodying the essence of industrial architecture. The locomotive sector emphasizes the creation of structures that support the safe and effective manufacturing, upkeep, and storage of locomotives and their associated equipment. Extensive buildings are typically defined by expansive, unobstructed areas, durable construction materials, and practical layouts that enhance operational efficiency. The design of locomotive workshops and factories necessitates spacious interiors to accommodate the substantial dimensions of locomotives and the heavy machinery involved in their assembly and repair, and highlighting the industrial aesthetic and functional purpose of the buildings. Furthermore, the design prioritizes the safe movement of materials, personnel, and vehicles, thereby optimizing production and maintenance workflows. This building may be the sole remaining edifice from 1937 within Thailand's industrial landscape, showcasing a careful blend of functionality and aesthetic appeal. The period during which this building was constructed signifies a pivotal shift in engineering methodologies, as designers aimed to improve locomotive performance and efficiency while also prioritizing the visual characteristics of the buildings. Consequently, locomotive buildings not only functioned as operational centers but also embodied the industrial progress and artistic values of the era, thereby playing a significant role in the historical narrative of the regional industry. The walls are constructed using bricks with a thickness of 45 mm. The roofing features a triple-height volume, utilizing roofing sheets that are consistent with those used elsewhere, specifically compressed concrete sheets. However, the roofing structure employs a steel bracing technique, which offers greater flexibility for the building's movement and allows for significant cross ventilation (**Figure 29**).

Figure 29: Architectural and overview of Building E, locomotive area

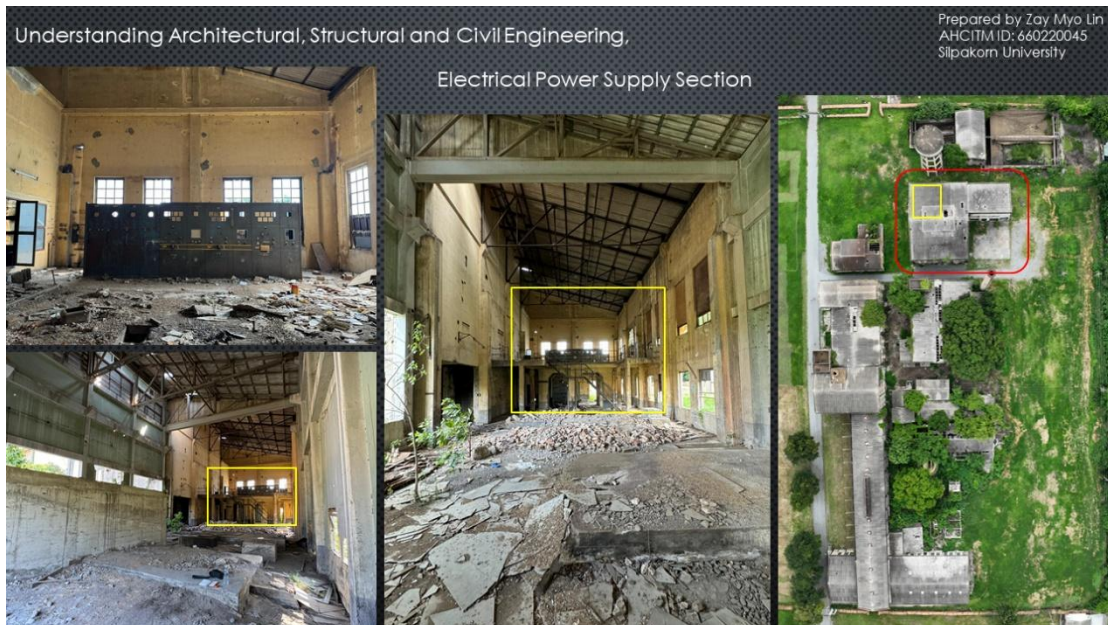
A significant electrical power distribution panel is situated on the mezzanine level of Building E, next to the Locomotive section (**Figure 33**). However, its construction and installation may occur at a later stage, likely following the installation of a diesel locomotive capable of generating electricity. In contrast, a wood-fueled steam locomotive engine, in its conventional design, does not generate electricity directly; instead, it harnesses the heat produced from burning wood to create steam, which subsequently powers pistons to produce mechanical motion rather than electrical energy. The electrical power supply sector plays a crucial role in the functioning of modern society by generating, transmitting, and distributing electricity to various consumers, including residential, commercial, and industrial users. This sector ensures the availability of reliable and efficient energy, which is essential for powering homes, businesses, and essential services. Additionally, it supports economic growth and development by facilitating technological advancements and improving the quality of life. The sector also faces challenges such as the need for sustainable energy sources and the integration of renewable technologies, which are vital for addressing environmental concerns and ensuring long-term energy security.

Figure 33: Electrical Power Distribution Sector at Building E
Photo by Zay Myo Lin, (2024).

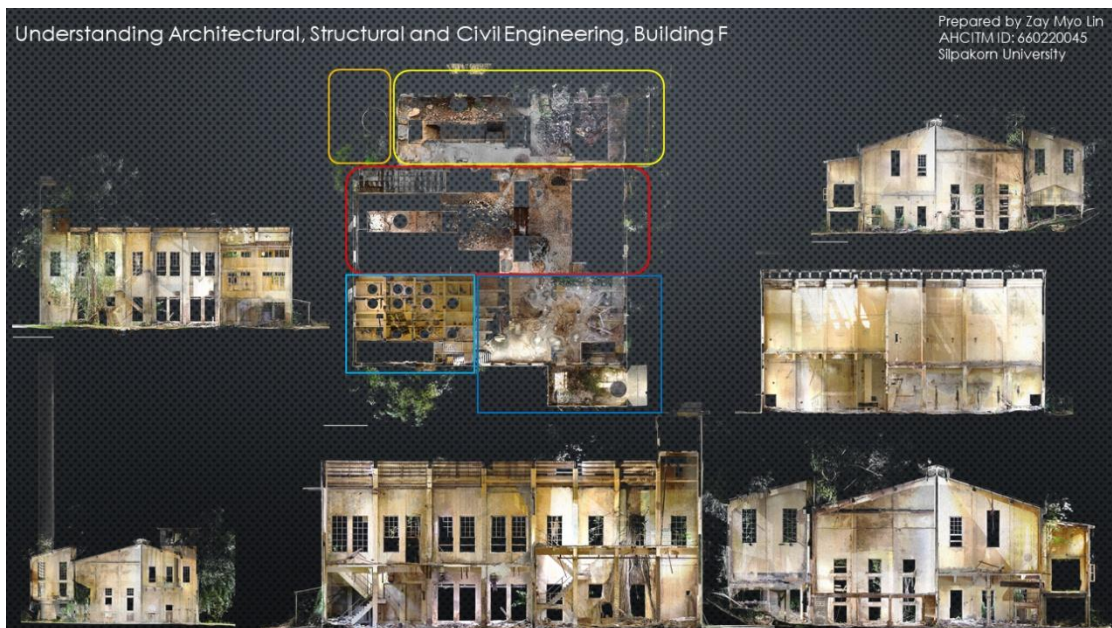
Figure 34: Layout plan, elevation and section of Building F 3D picture by Professor Isarachai Buranaut, (2024).
