OBSERVATION AND CONSERVATION REPORT ON KANCHANABURI PAPER
MILL; INDUSTRIAL HERITAGE OF THAILAND

Title Observation and Conservation Report on Kanchanaburi Paper Mill;
Industrial Heritage of Thailand
By Mr. Zay Myo LIN
Field of Study Architectural Heritage, Creative Industries and Tourism
Management (International Program) Plan B
Advisor Associate Professor Kreangkrai Kirdsiri, Ph.D.

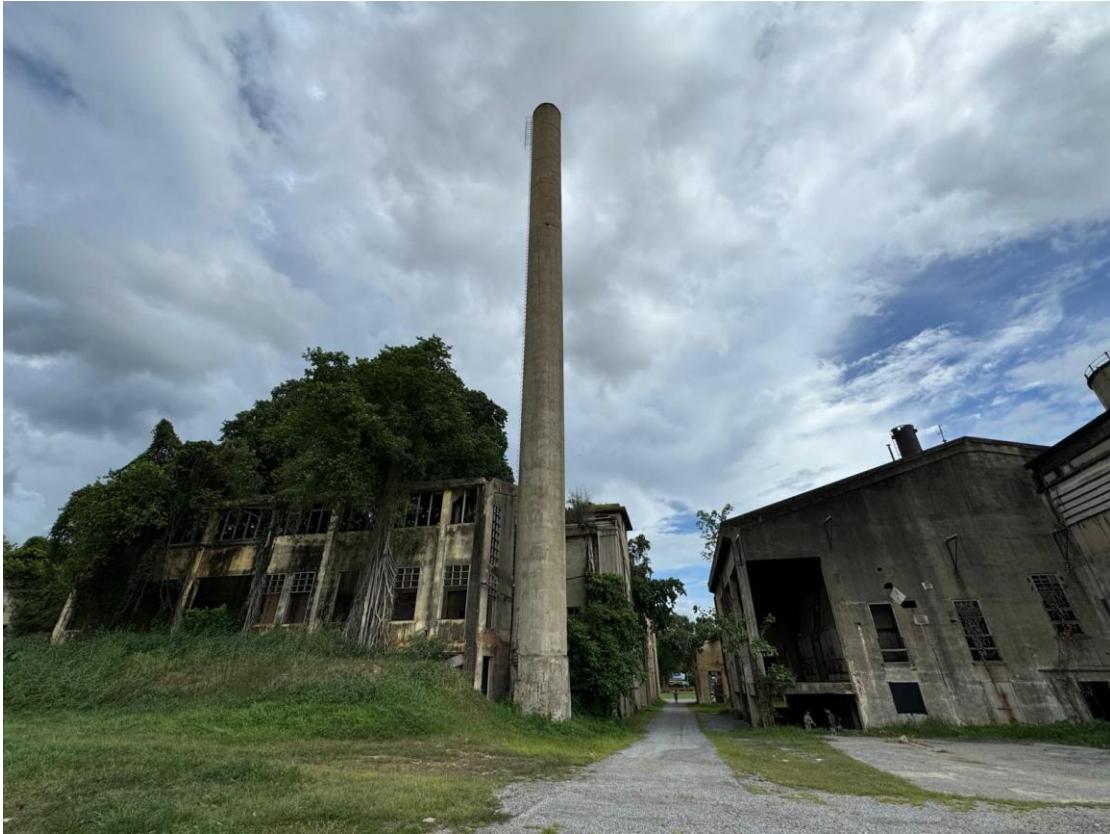
Figure 36: Reinforced concrete Industrial Chimney build in 1937
Photo by Zay Myo Lin (2024).

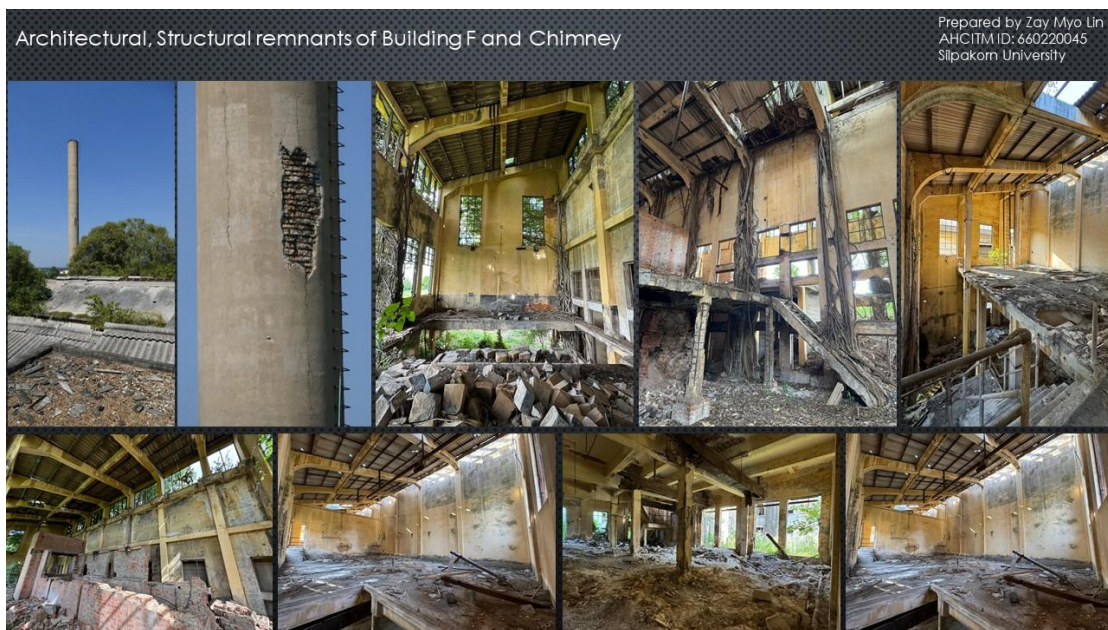
Figure 37: Architectural and structural remnants of Building and Chimney
Photo by Zay Myo Lin (2024).

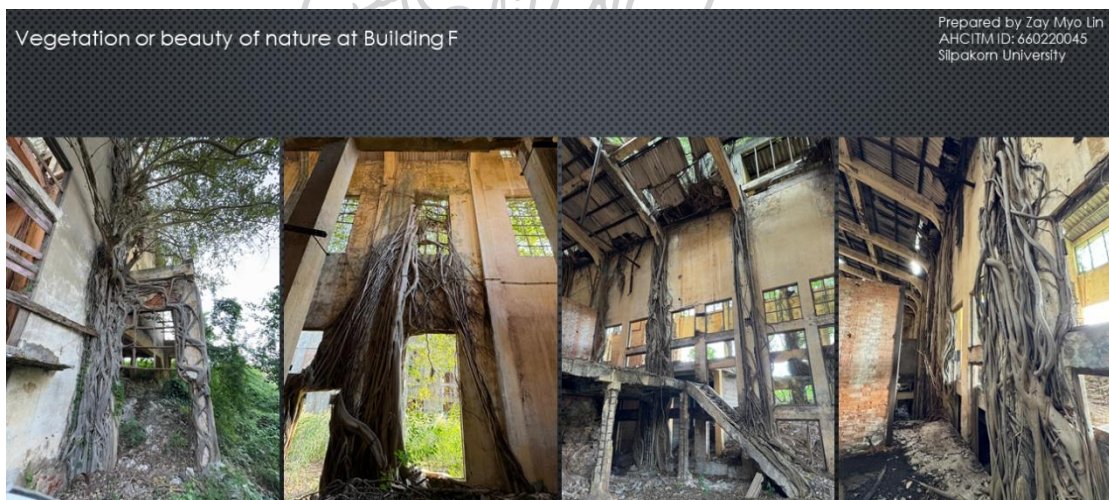
Figure 38: Vegetation at Building F
